WATERBAY TOWER C PROGRESS REPORT

Project Developer	Bin Faqeeh Real Estate Investment Company S.P.C.
Title of Project	Waterbay Tower C
Project Reference	BFWBC/16/01110-31110/2020
Design & Supervision Consultant	Arab Architects
Interior Design Consultant	(East) Dar Al Décor
Main Contractor	Al Jameel Construction S.P.C.

Title of Document	Progress Report of Waterbay Tower C
Reporting Period	October 1, 2020 to October 31, 2020
Authors & project role	Al Jameel Construction S.P.C.
Date	November 9, 2020

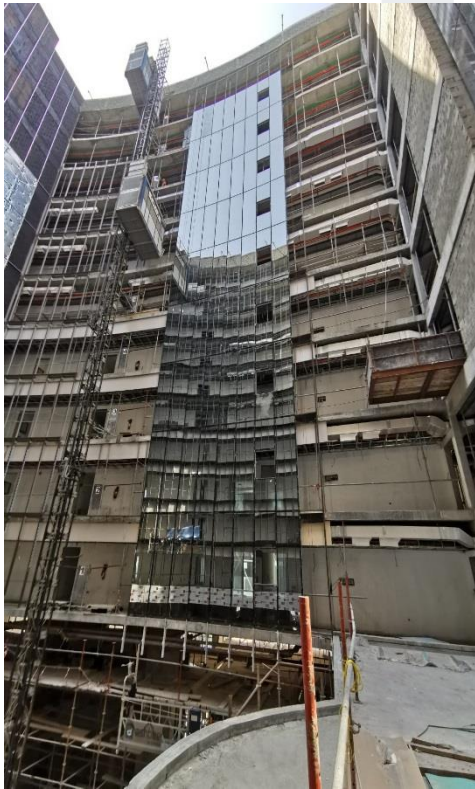
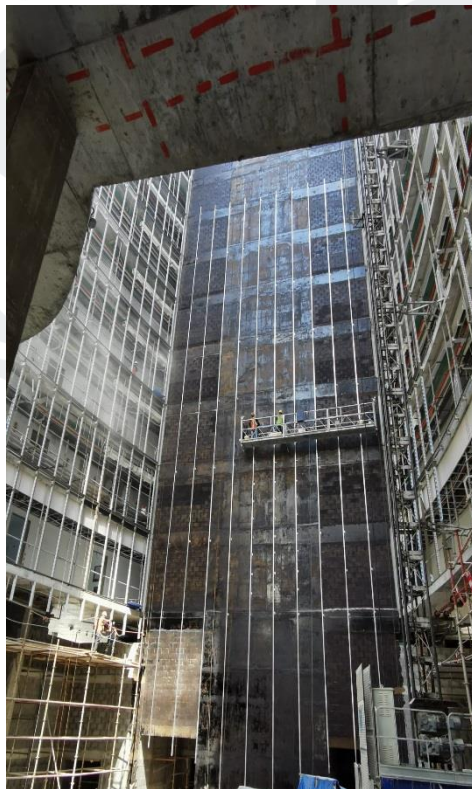
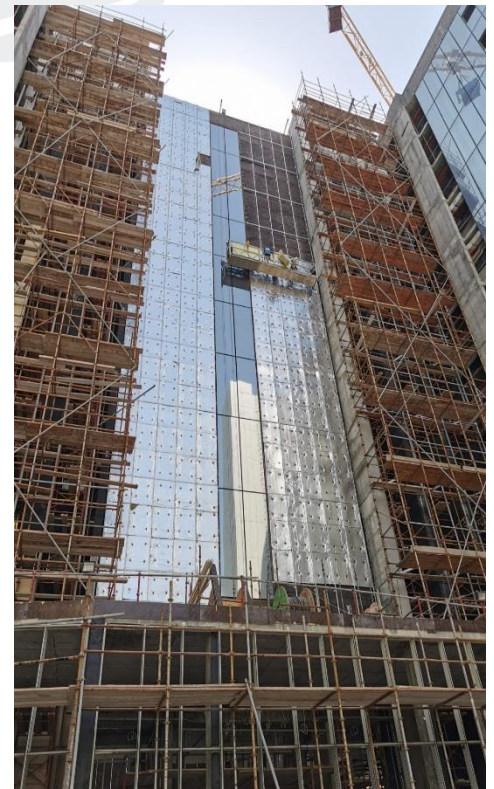
Installation of Aluminum Works (Brackets, Mullion, Rockwool ACP Cladding & Glass and Application of Bitumen Paint)

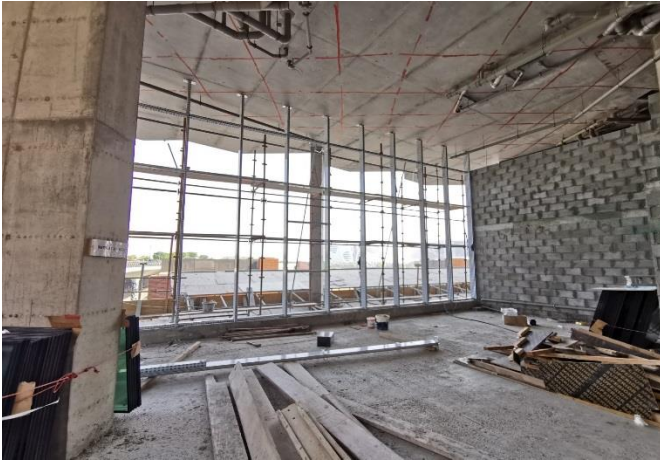
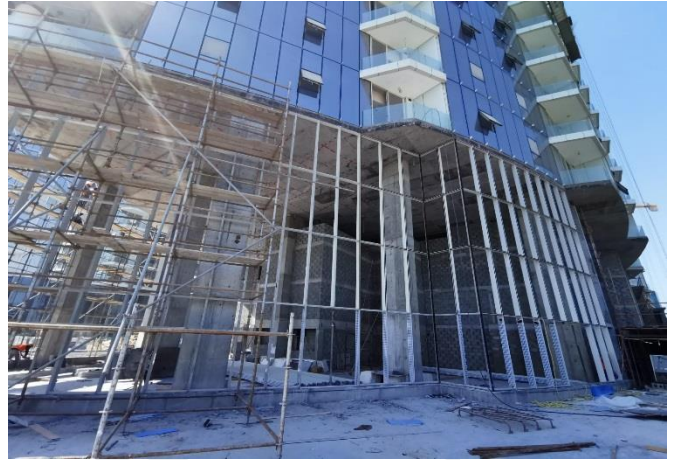
Installation of Aluminum Works (Brackets, Mullion, Rockwool ACP Cladding & Glass and Application of Bitumen Paint)

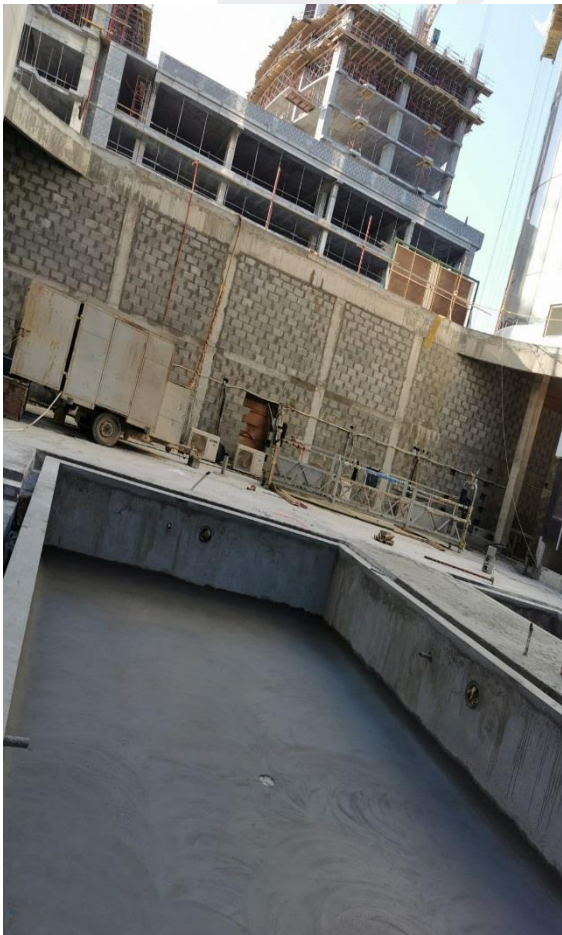
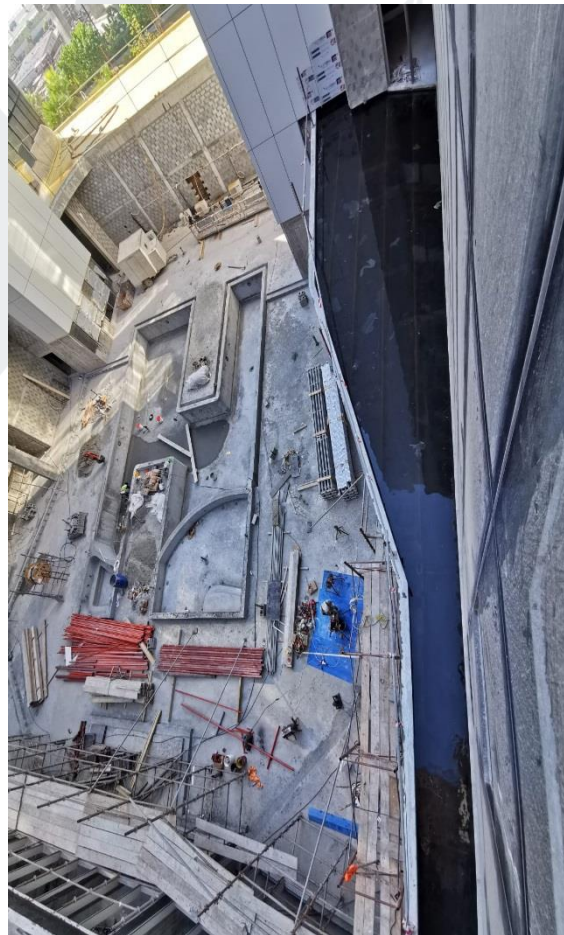
Swimming Pool Works at Ground Floor

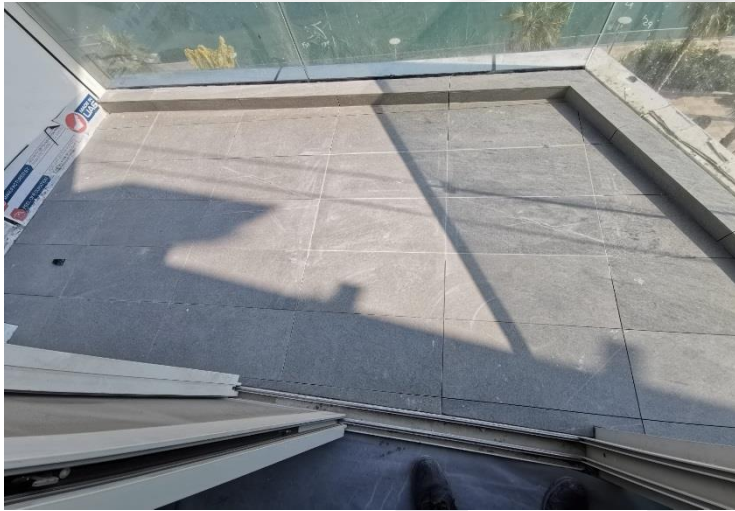
Marble Works for Balcony Area at Typical Floors

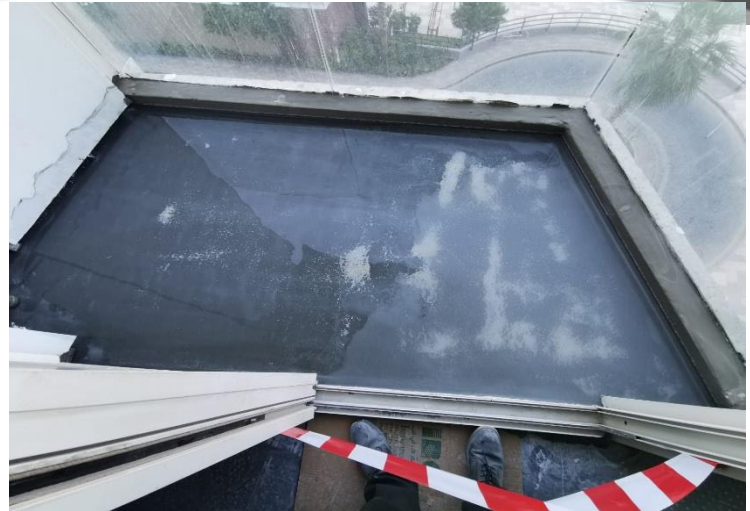
Waterproofing Works for Balcony Area

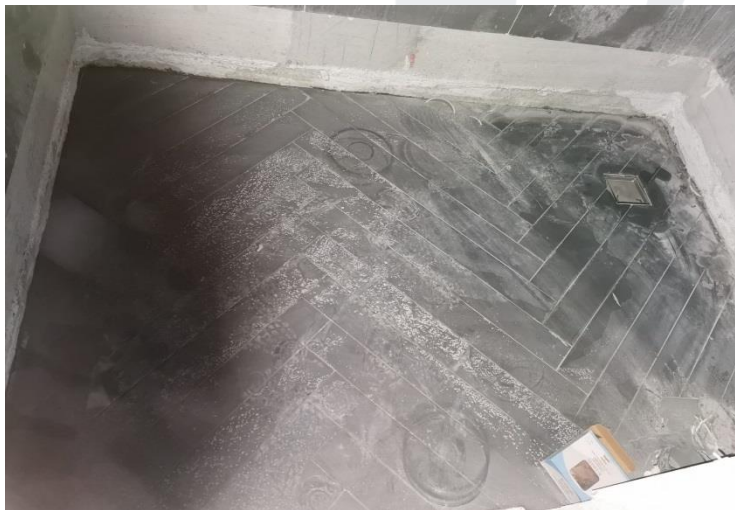
Marble Floor Works for Toilet at Typical Floors

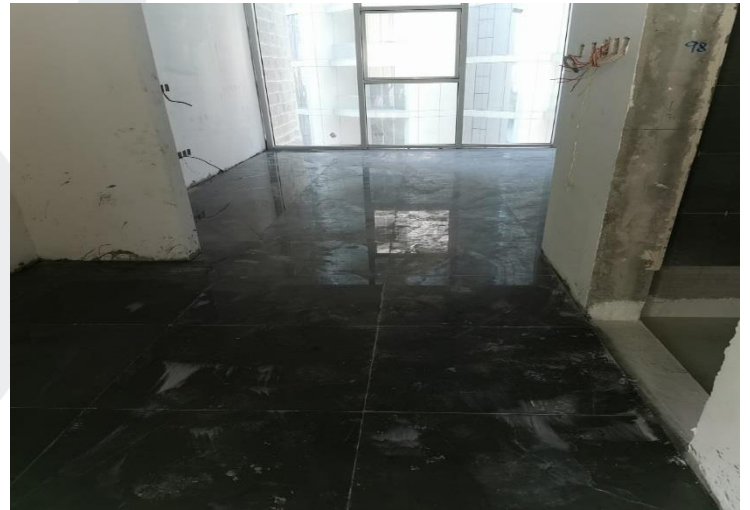
Marble Floor for Flats at Typical Floor

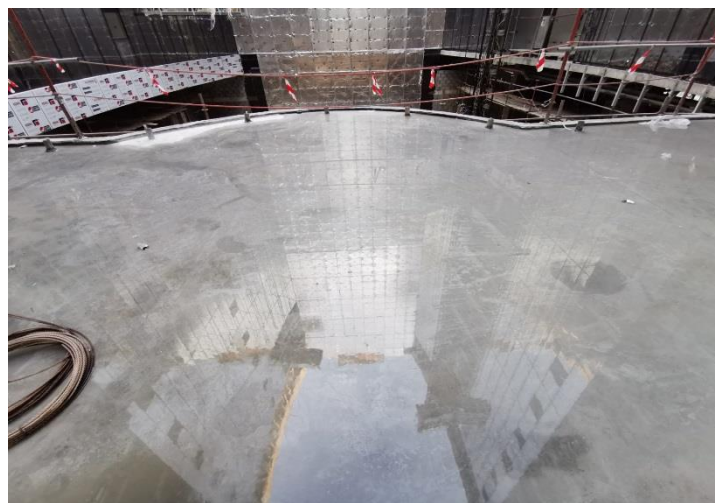
Water Leakage Test for Terrace Area at 1st Floor
