## AL SIDRA PH1 PROGRESS REPORT

<b>Project Developer</b>	Bin Faqeeh Real Estate Investment Company S.P.C.
<b>Title of Project</b>	Al Sidra Villa
<b>Project Reference</b>	BFALSIDRAPH1/05/0107-3107/2020
<b>Design &amp; Supervision Consultant</b>	MSCEB
<b>Interior Design Consultant</b>	Horizon Interiors
<b>Main Contractor</b>	Al Jameel Construction SPC

<b>Title of Document</b>	Progress Report of Al Sidra
<b>Reporting Period</b>	July 1, 2020 to July 31, 2020
<b>Authors &amp; project role</b>	MSCEB
<b>Date</b>	August 11, 2020

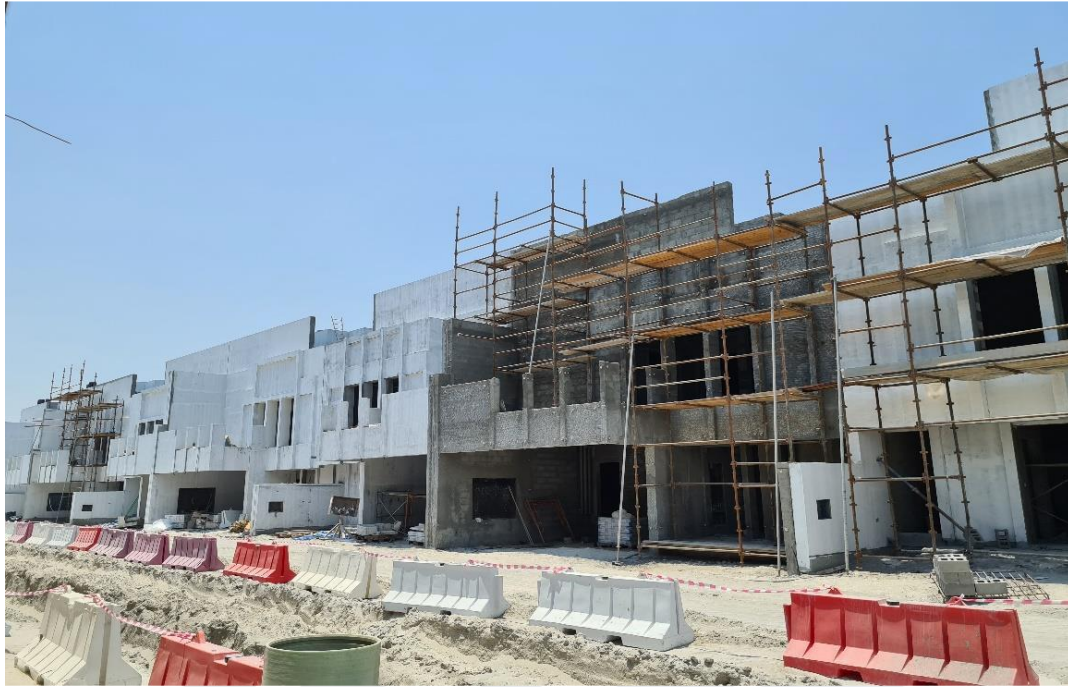
*External Plastering works in progress*

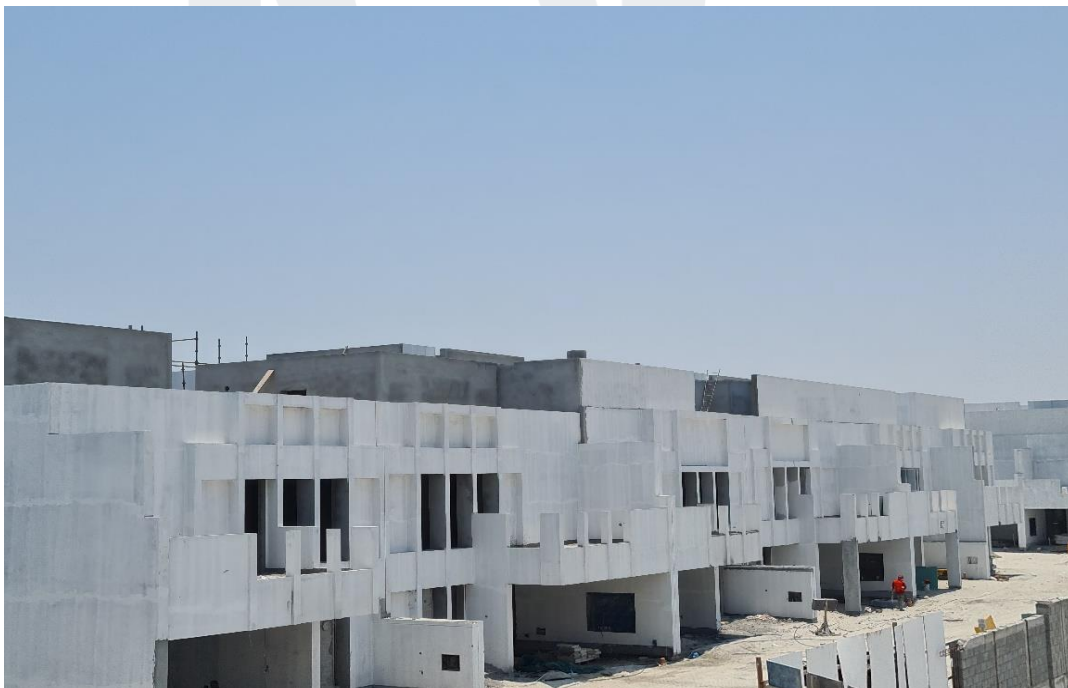
*External Painting works in progress*

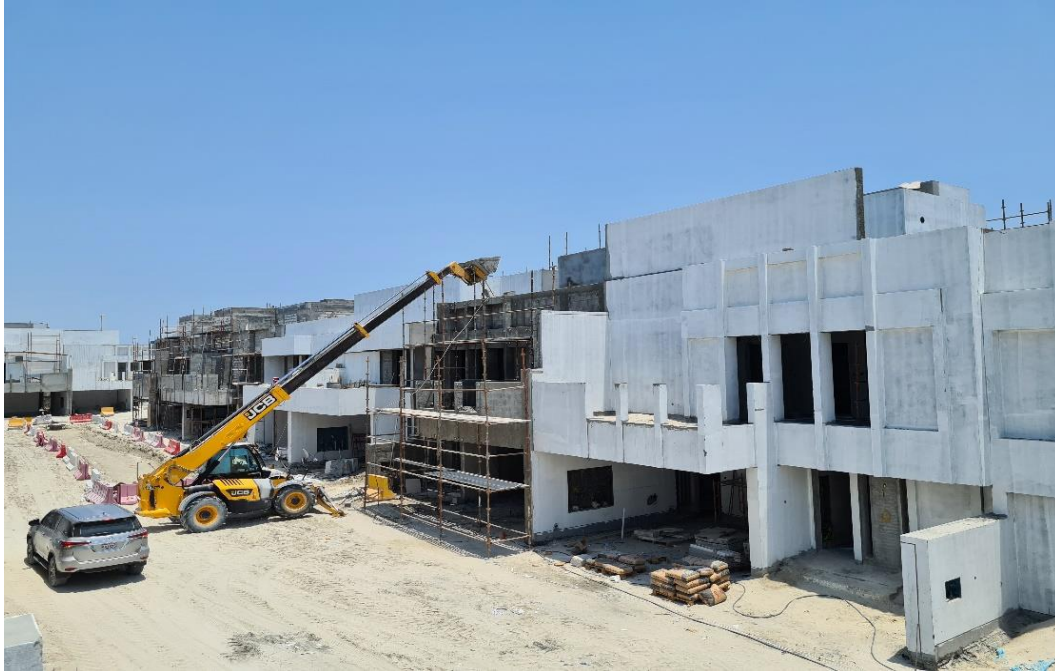
*External Plastering works in progress*

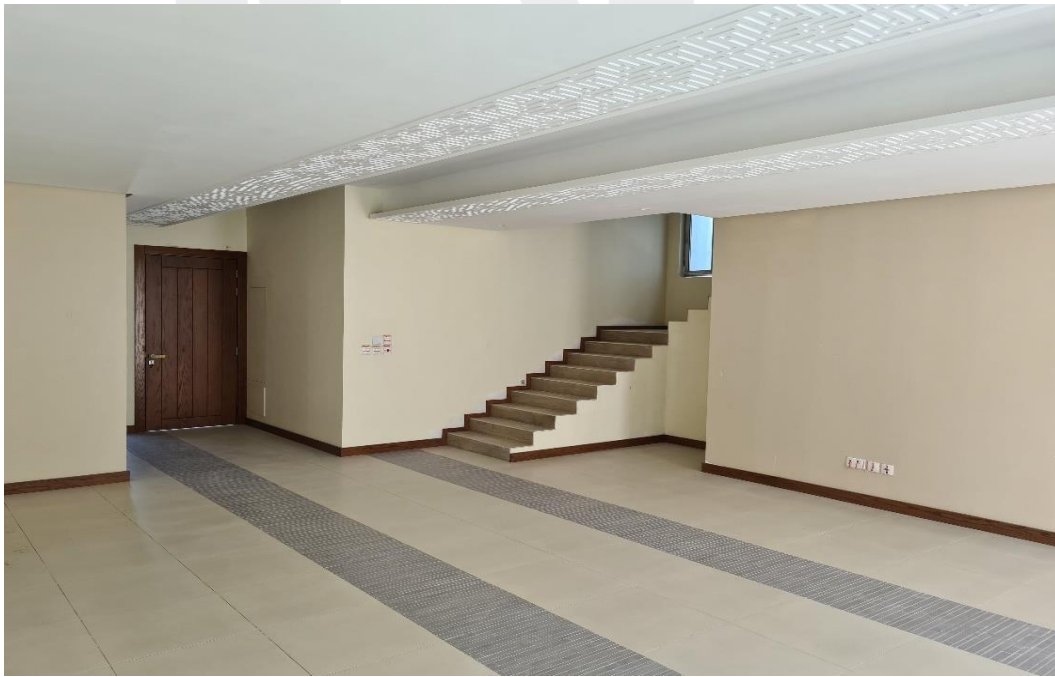
*Internal Paint application in progress*

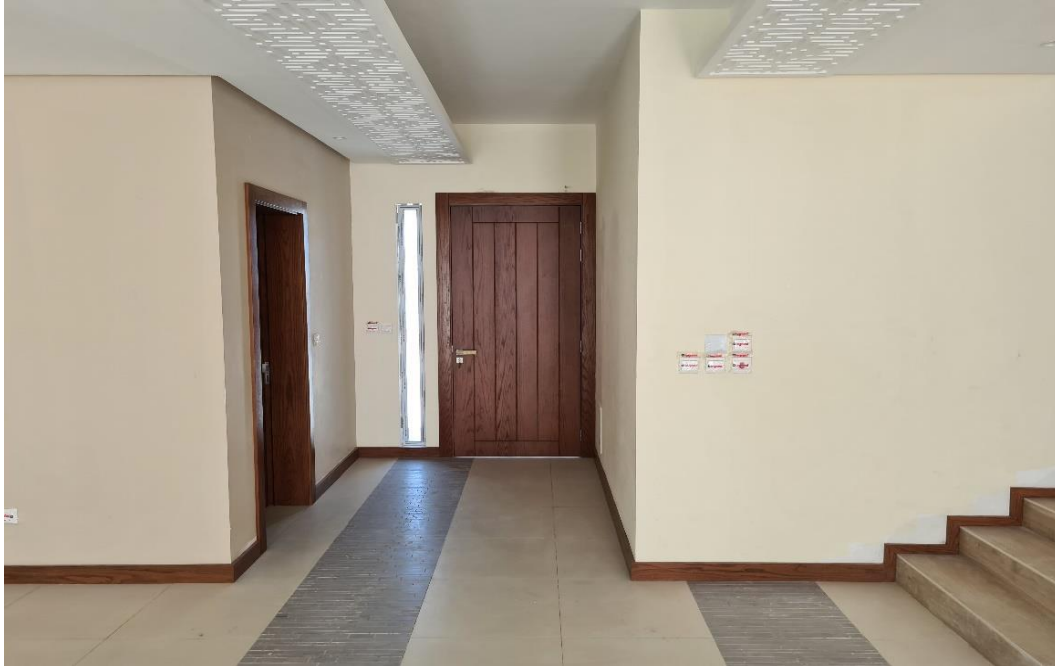
*Wooden Doors and Skirting installation in progress*

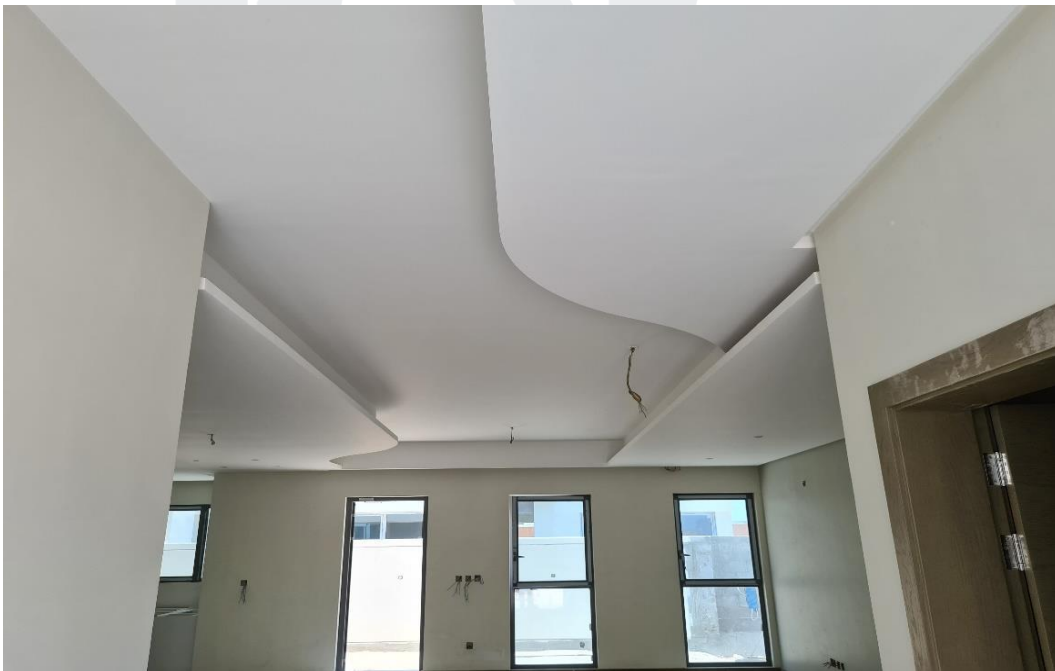
*Aluminum Windows installation in progress*
