AL SIDRA PH1 PROGRESS REPORT

Project Developer	Bin Faqeeh Real Estate Investment Company S.P.C.
Title of Project	Al Sidra Villa
Project Reference	BFALSIDRAPH1/09/01111-3011/2020
Design & Supervision Consultant	MSCEB
Interior Design Consultant	Horizon Interiors
Main Contractor	Al Jameel Construction SPC

Title of Document	Progress Report of Al Sidra
Reporting Period	November 1, 2020 to November 30, 2020
Authors & project role	MSCEB
Date	December 6, 2020

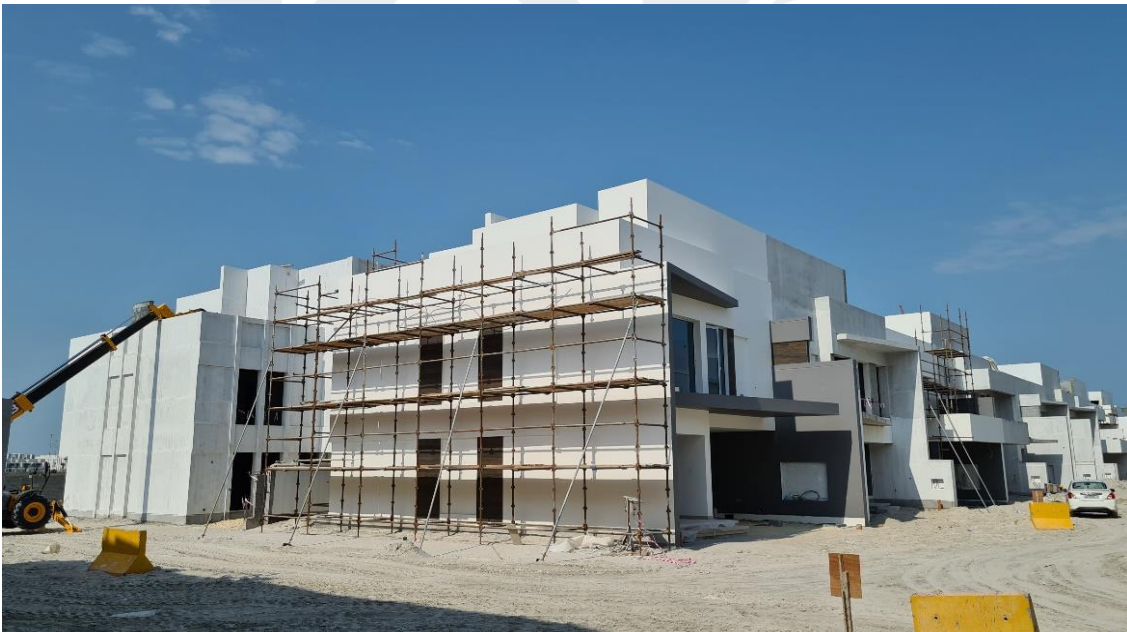
External Painting works in progress

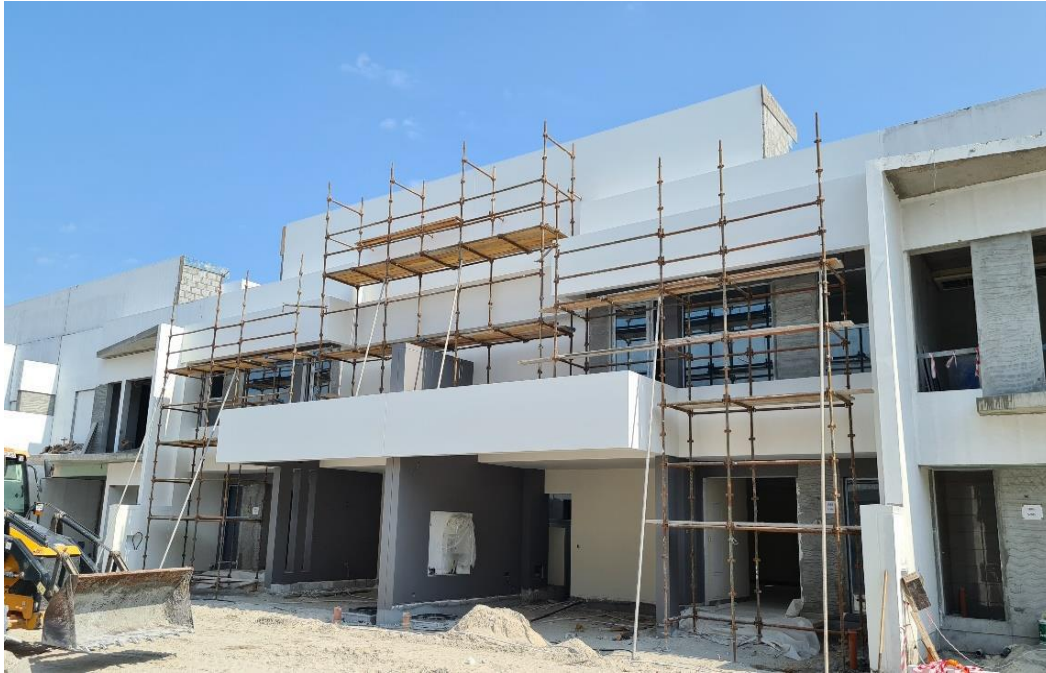
External Cladding Tile Installation in progress

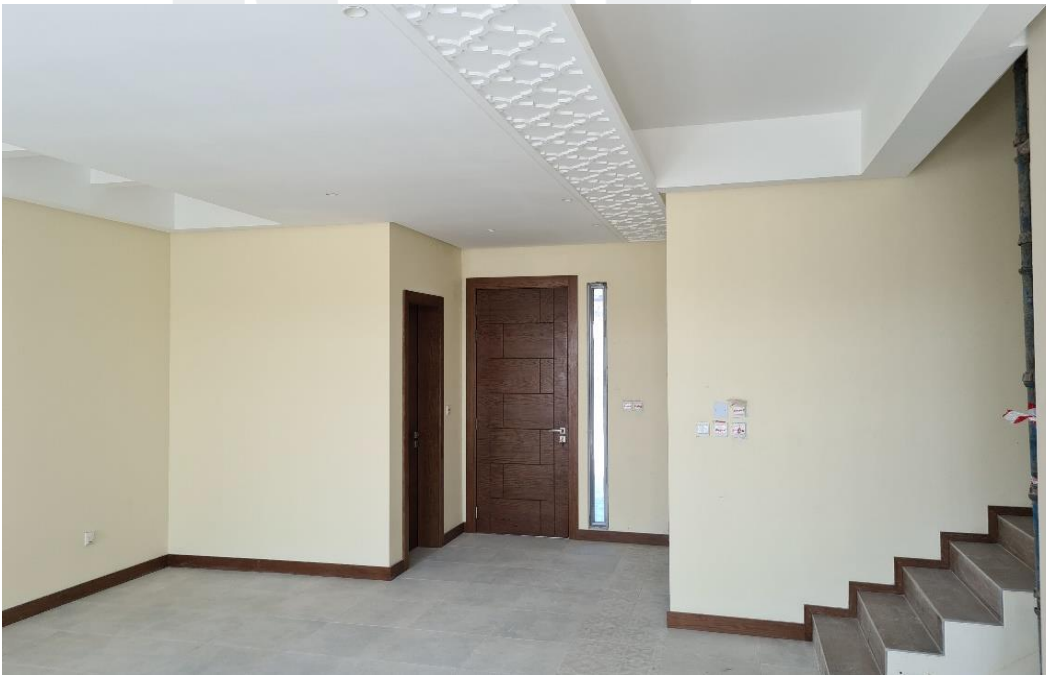
Internal Paint application in progress

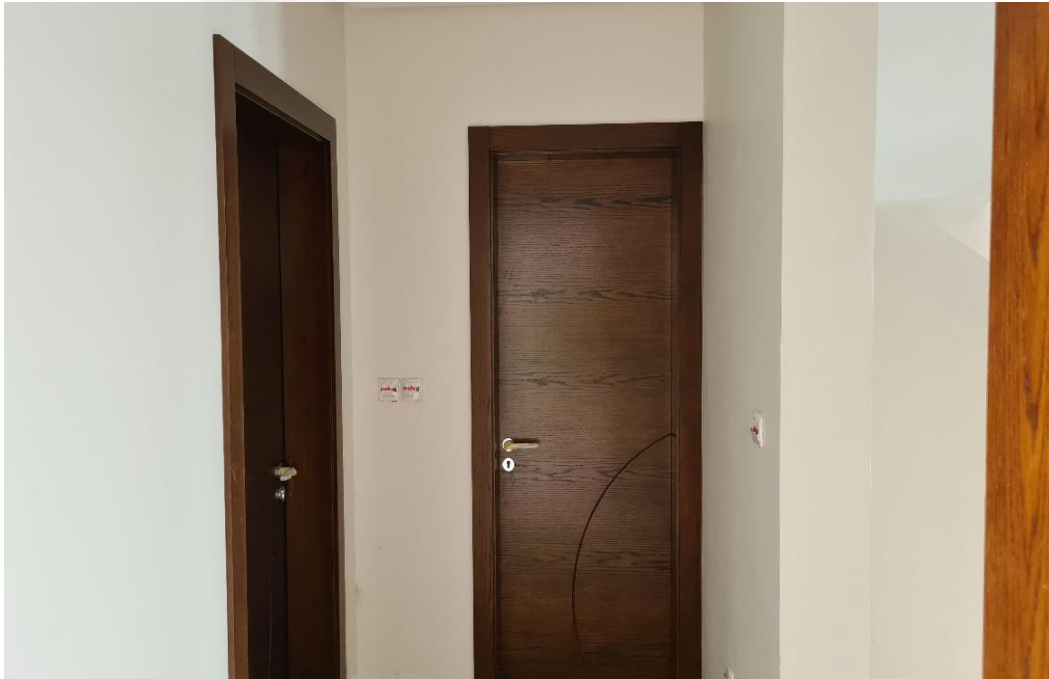
Wooden Doors & Skirting installation in progress

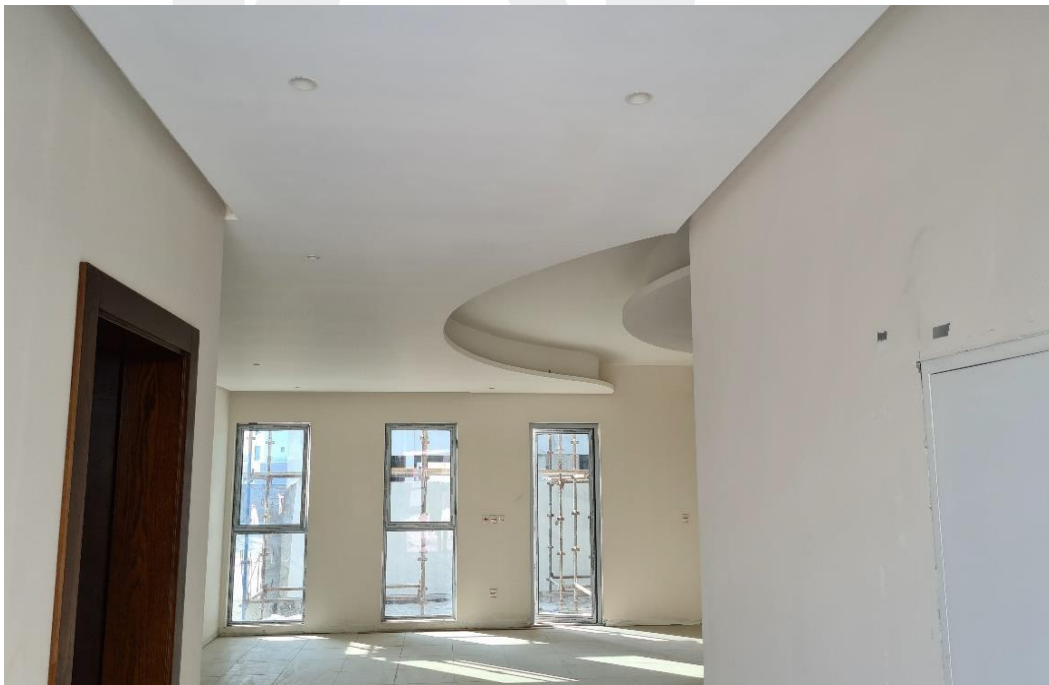
Villas Ceiling works in progress
