WATERBAY TOWER A PROGRESS REPORT

Project Developer	Bin Fageeh Real Estate Investment Company S.P.C.
Title of Project	Waterbay Tower A
Project Reference	BFWBA/16/0108-3108/2020
Design & Supervision Consultant	Arab Architects
Interior Design Consultant	(West) Roar
Main Contractor	Al Jameel Construction S.P.C.

Title of Document	Progress Report of Waterbay Tower A
Reporting Period	August 1, 2020 to August 31, 2020
Authors & project role	Al Jameel Construction S.P.C.
Date	September 6, 2020

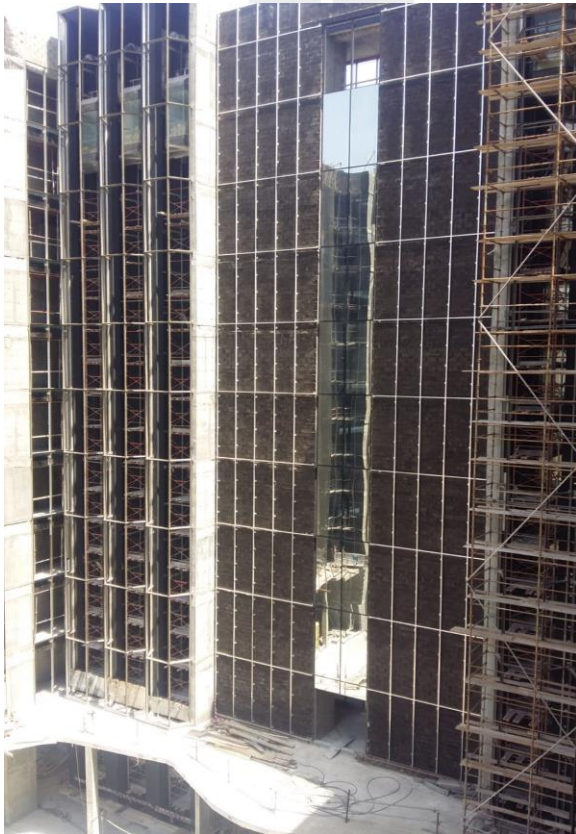
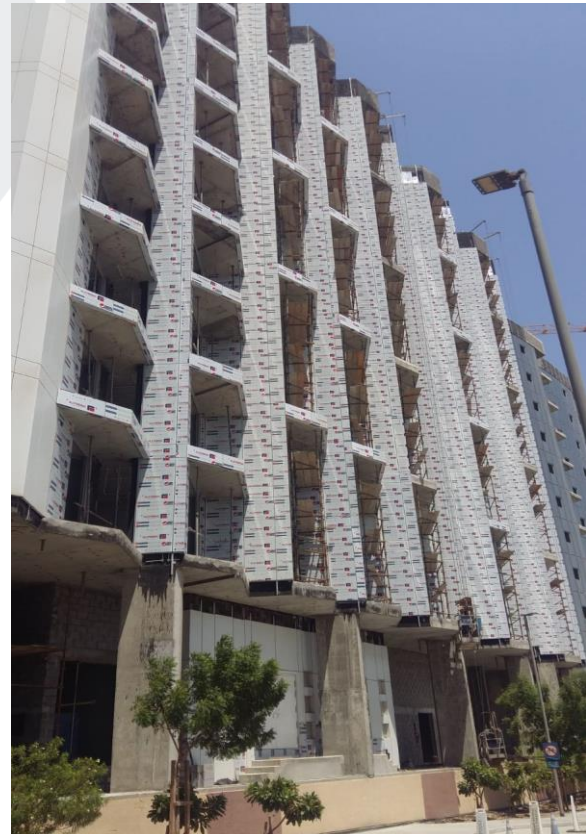
Installation of Aluminum Works (Brackets, Mullion, Rockwool, ACP Cladding and Glass and Application of Bitumen Paint)

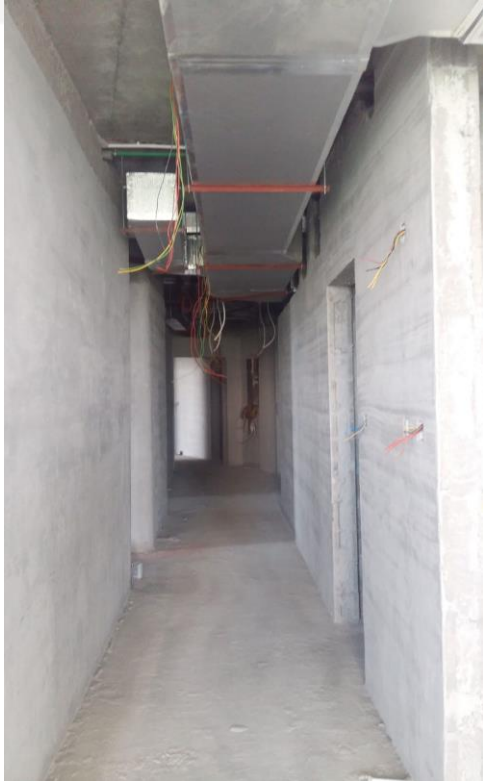
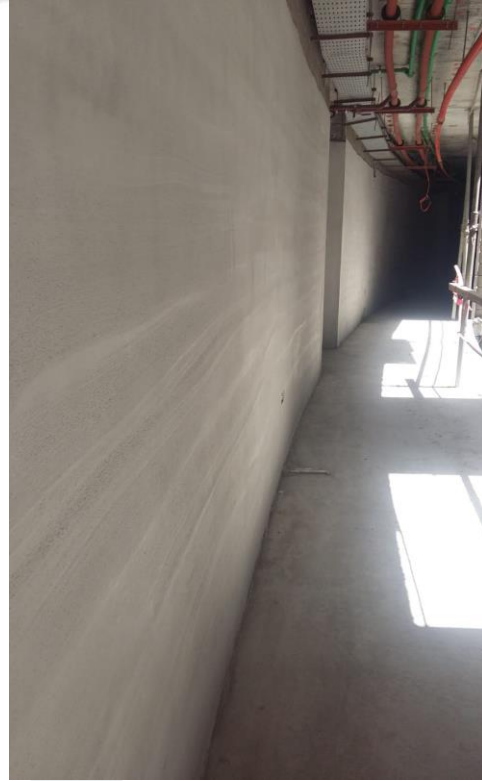
Plastering works at Typical Floors

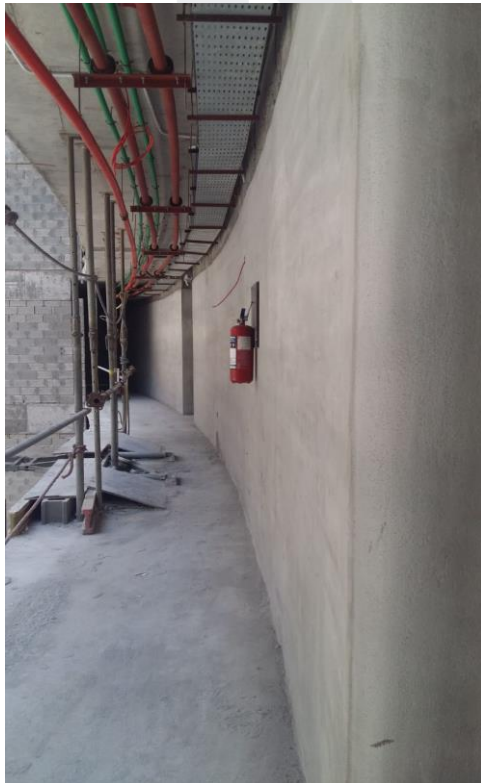
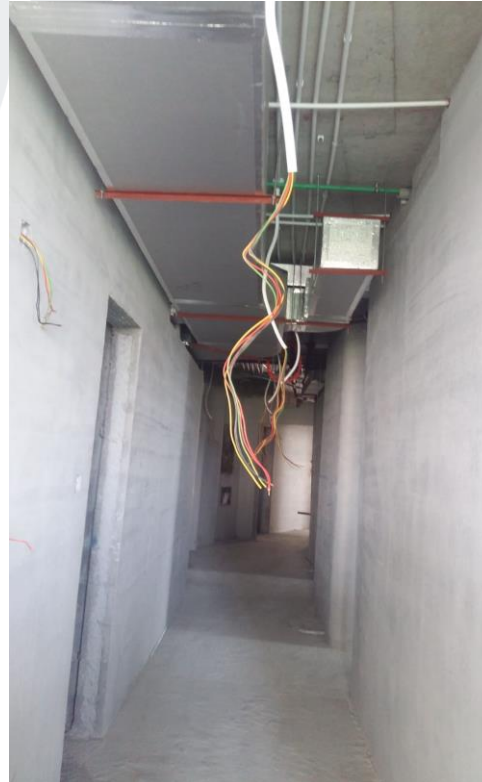
Plastering Works and Installation of MEP Services Works at Typical Floors
